VORTEX MARINE CONSTRUCTION

Job Title: Ballena Isle Breakwater Construction
Location: Alameda, CA
Owner: Almar Management, Inc.
Prime: Vortex Marine Construction
Date: December 2004 - Present
Description: Breakwater Replacement

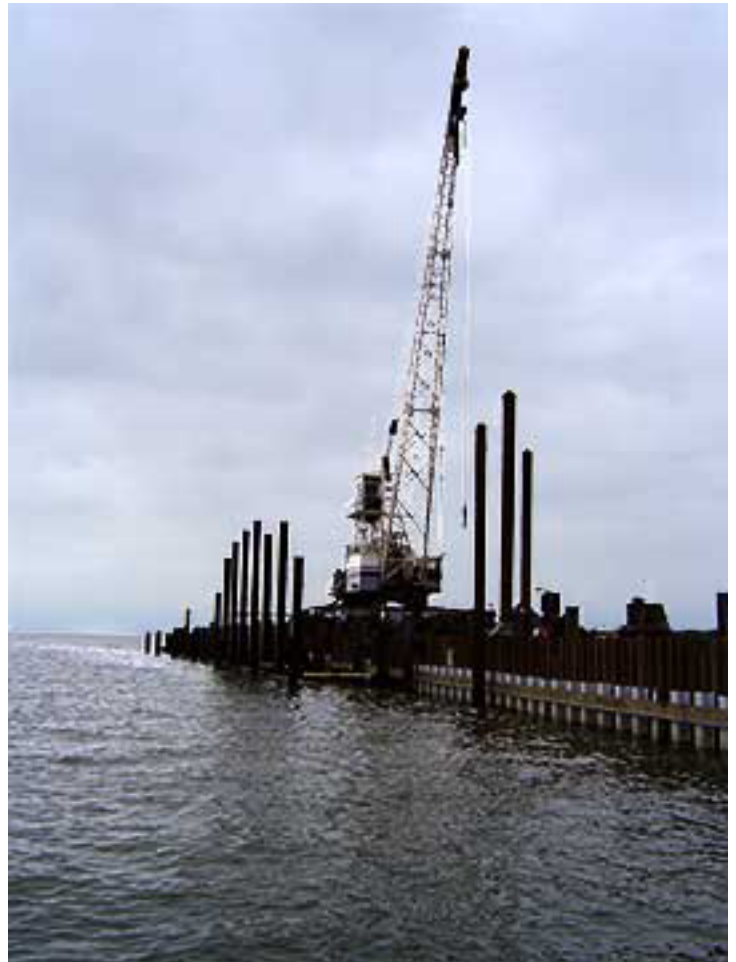
Vortex is replacing the existing timber breakwater with a 378' long concrete panel breakwater. This includes 12' wide x 24' high concrete panels set between 105' long plumb/batter piles.
